## TEST REPORT

1. **Report Number** KCTL16-YRS0171
2. **Applicant**
- Name Hanwha Techwin Co.,Ltd
  - Address 1204, Changwon-daero, Seongsan-gu, Changwon-si, Gyeongsangnam-do, Korea

4. **Use of Report** For Quality management
5. **Test item description**
- Product Name Network Camera
  - Model Name PNO-9080R\*(N:NTSC/P:PAL)
6. **Test method used** IEC 60529 / IP66

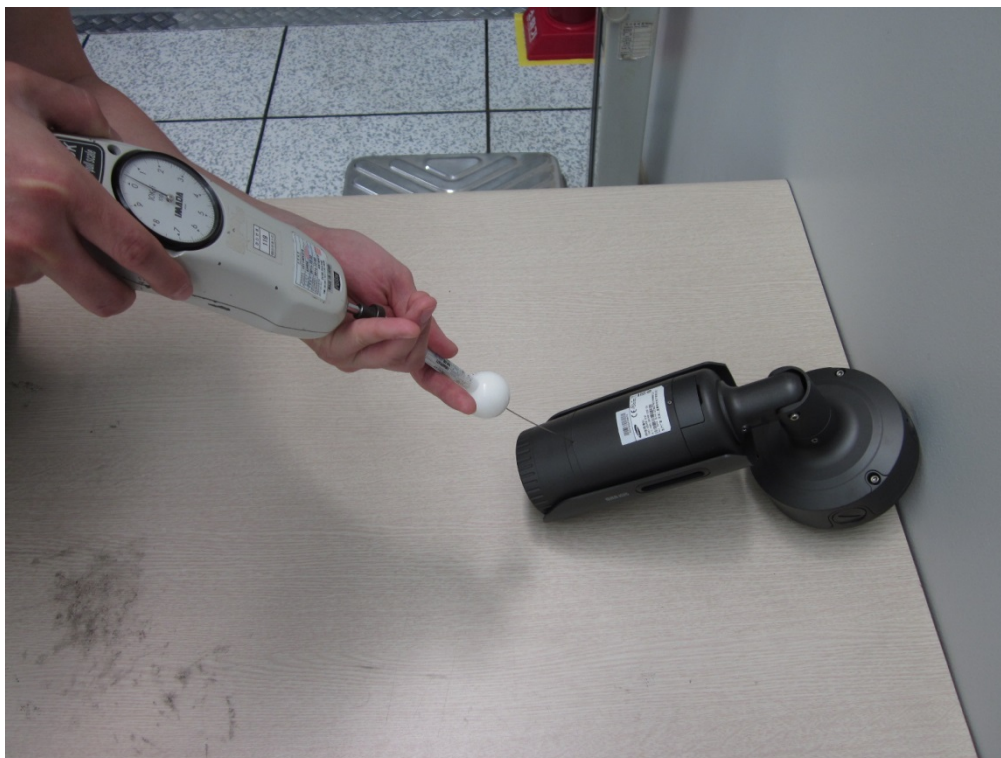
[During the test]

| Check List | Test Result |
|---|---|
| Protected against access to hazardous parts with a wire | No abnormal was found |

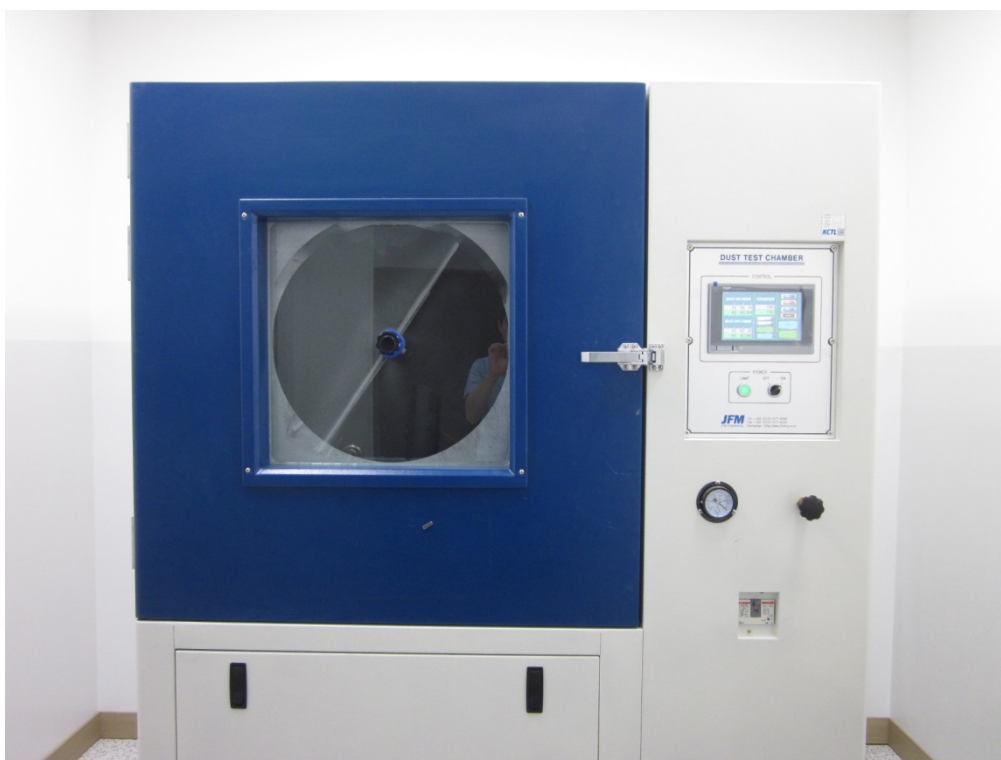
[During the test]

| Check List | Test Result |
|---|---|
| Dust-tight | No abnormal was found |

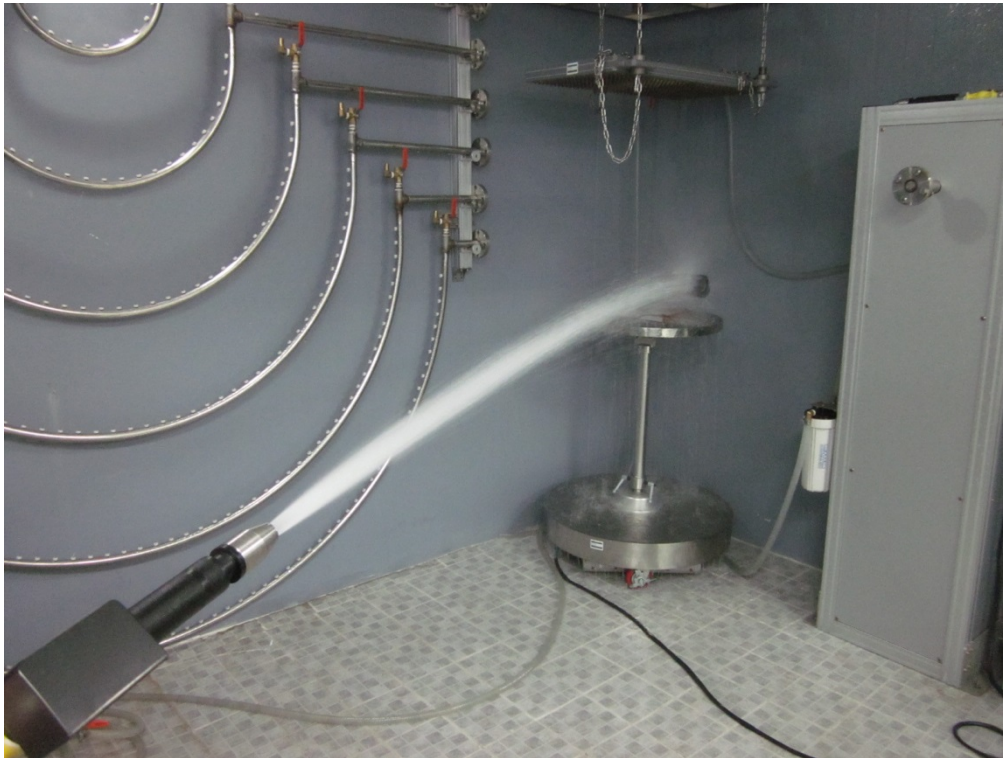
[During the test]]

| Check List | Test Result |
|---|---|
| Protected against powerful water jets | No abnormal was found |

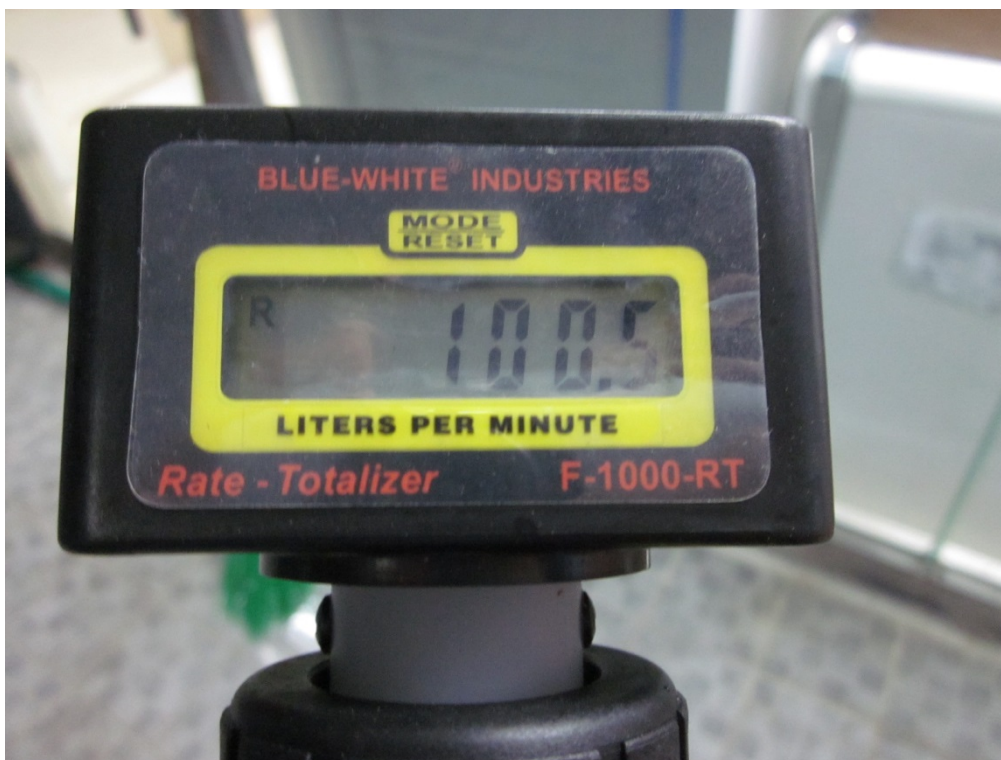
[During the test\_Water flow rate]

| Item | Description |
|---|---|
| Test condition | 1. Water jet hose nozzle diameter: 12.5 mm<br>2. Water flow rate: 100 L/min $\pm$ 5%<br>3. Distance: 2.5~3.0 m |
